**REPAIRS WORKS OF DAMAGED CONCRETE STRUCTURES AT SEA
RASCO HARBOUR BERTH 3A & 3B CAISSONS REHABILITATION - ABOVE WATER AREA**

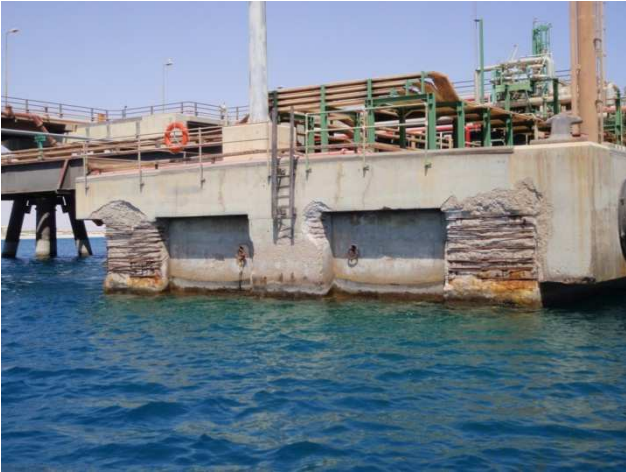
Photo no. 1

Photos no. 1 and 2 evidence the conditions of the concrete structures and rebars.

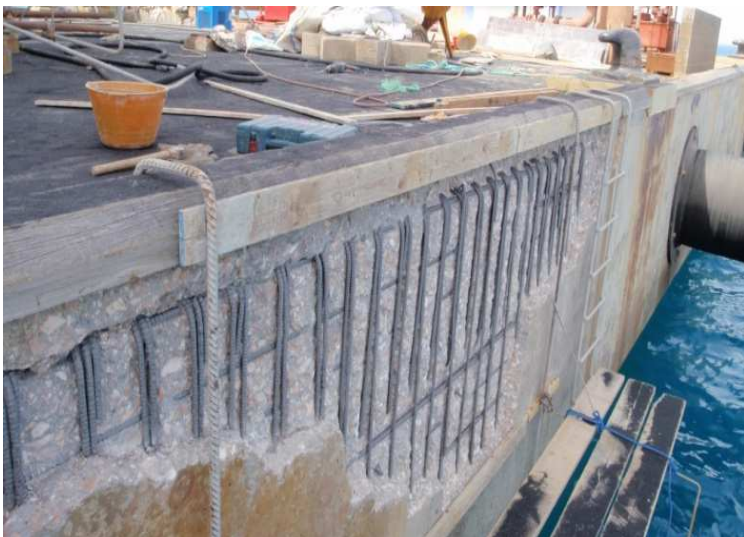
Photo no. 3

Photos no. 3 and no. 4 (left side) evidence rebars and concrete duly sandblasted after all deteriorated concrete has been mechanically removed and insufficient rebars replaced .

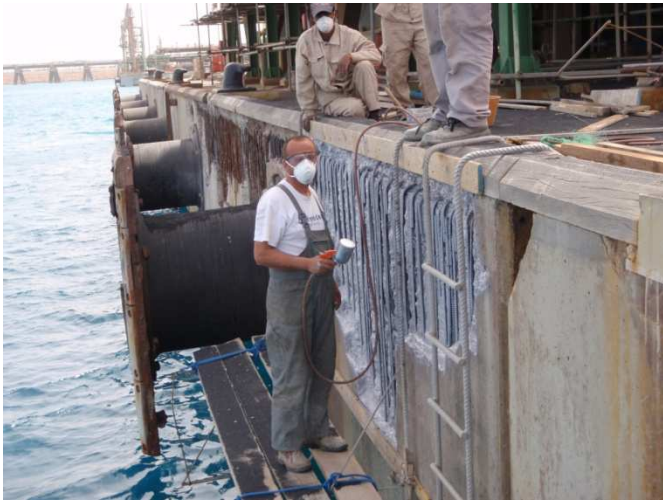
Photo no. 5

Photos no. 5, 6 and 7 evidence the application of L.A.2S Epoxy for corrosion protection of rebars and as adhesion promoter for the subsequent application of #108 MORTAR (Thixotropic, Non-Shrink, Sulphate Resisting Mortar).

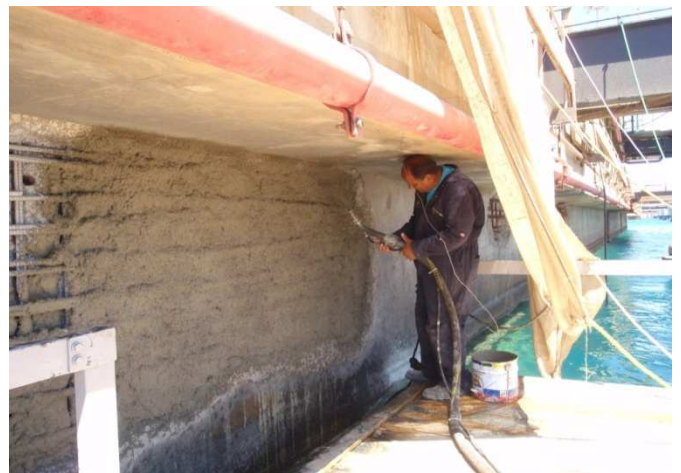
Photo no. 8 evidences the application of #108 MORTAR on L.A.2S epoxy adhesive still tackey.

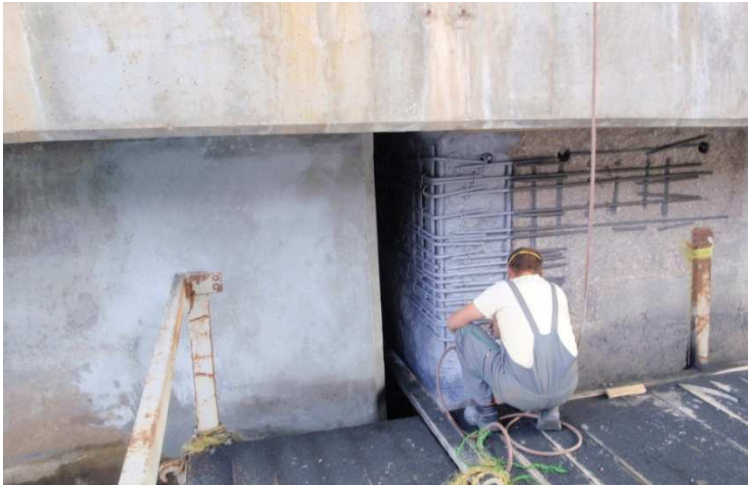
Photo no. 9

Photos no. 9 and 10 evidence the damaged area duly repaired with #108 MORTAR, before application of FSS COAT ELASTIC (Protective Coating).

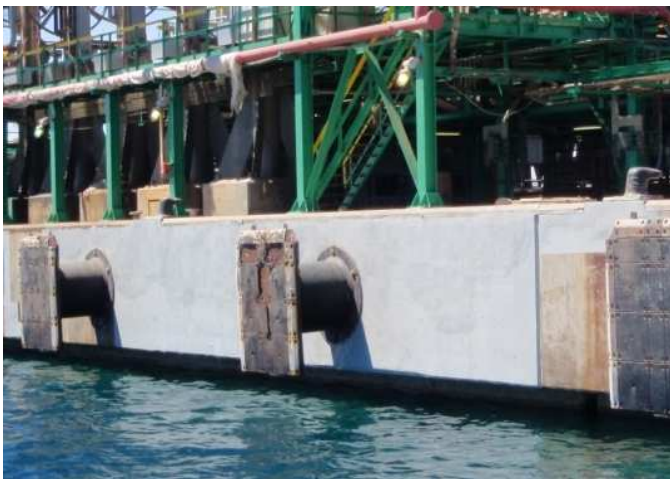
Photo n. 11

Photos no. 11 and 12 evidence the repaired areas coated with FSS COAT ELASTIC (Protective Coating).
