COBIGUA PORT – PUERTO BARRIOS (GUATEMALA)

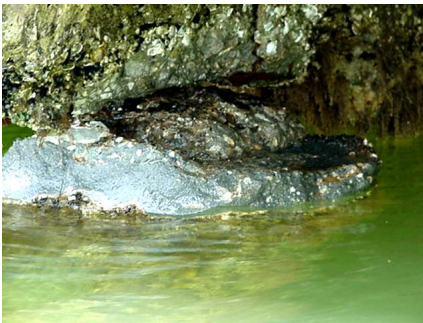
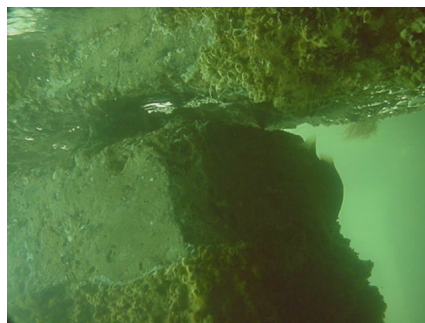
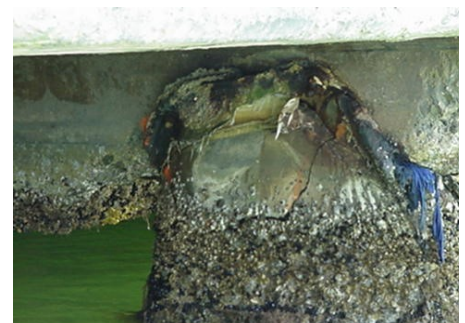
Damages were mostly caused by breakings between concrete piles and platform with wrecked concrete and heavy damages to the steel reinforcement. Many attempts were carried out by the Port Authorities to repair the damaged concrete piles with traditional systems but without results.

Typical ruptures between concrete piles and platform

Repair works varied from replacement by welding of the damaged reinforcement, filling up the cavities between platform and piles heads and reconstruction of the missing concrete above and under water using some 20.000 kilos of Subcom T.260, a thixotropic, solventless, two packs, epoxy mastic designed for underwater and other wet applications. Other special Sinit materials: INJECTION 1 low viscosity injection resin, #108 MORTAR, thixotropic, rheoplastic, non-segregating, non-shrink, high strength mortar, with high bond to steel and concrete, and L.A. 2S, two-component, low-viscosity, solventless, liquid epoxy adhesive were also used to complete the work.

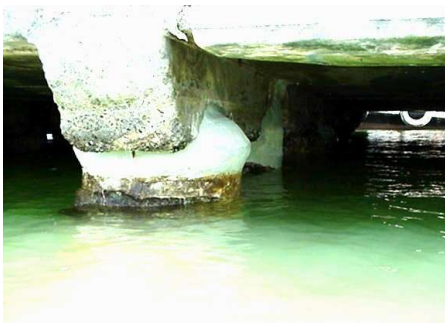
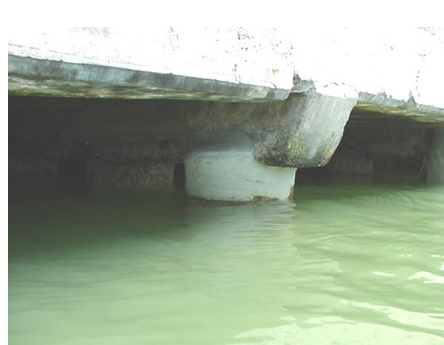
View of the rehabilitation with Subcom T.260 replacing concrete between piles and platform
